PASSAIC RIVER BASIN  
DEN BROOK, MORRIS COUNTY  
NEW JERSEY

# INDIAN LAKE DAM

PHASE I INSPECTION REPORT  
NATIONAL DAM SAFETY PROGRAM

NJ 00167

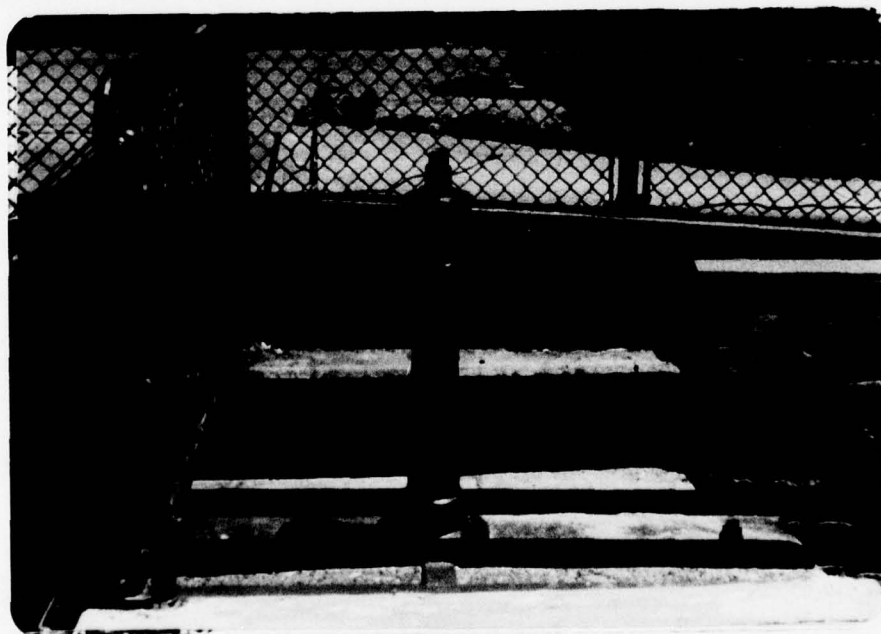
Drawdown control valve of upstream  
end of right sidewall

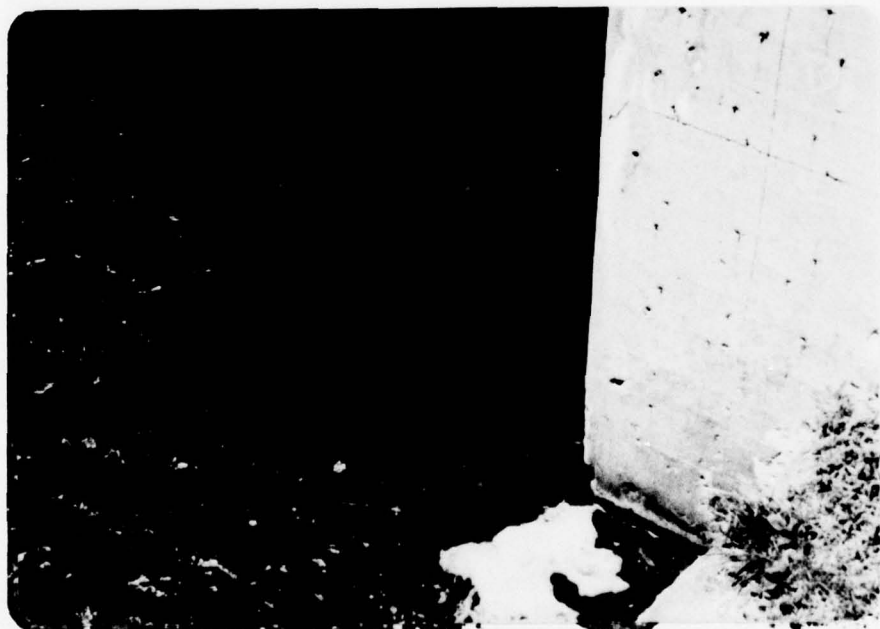
Steel sheet pile around right pier  
of Lake Estling discharge culvert  
under railroad

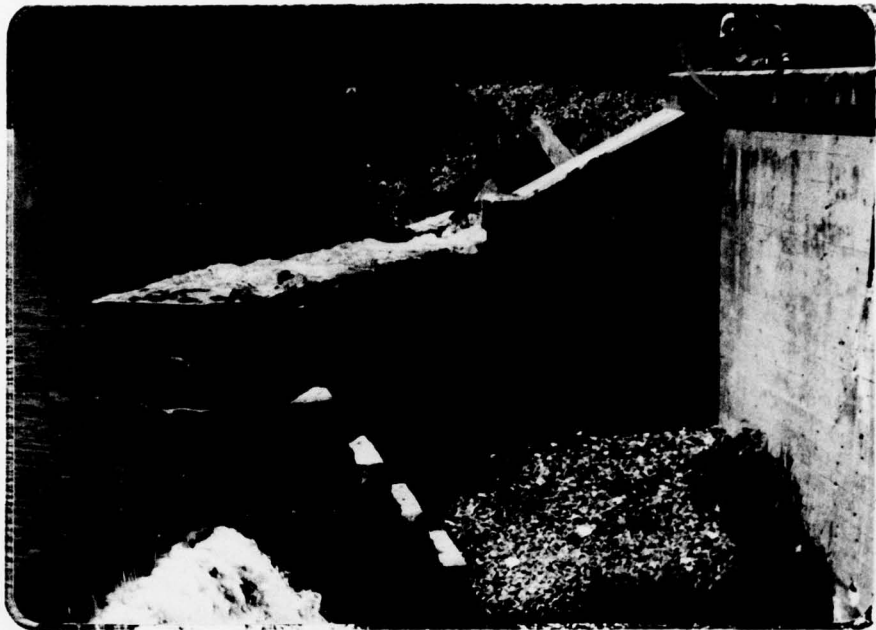
Left abutment of spillway from  
Lake Estling

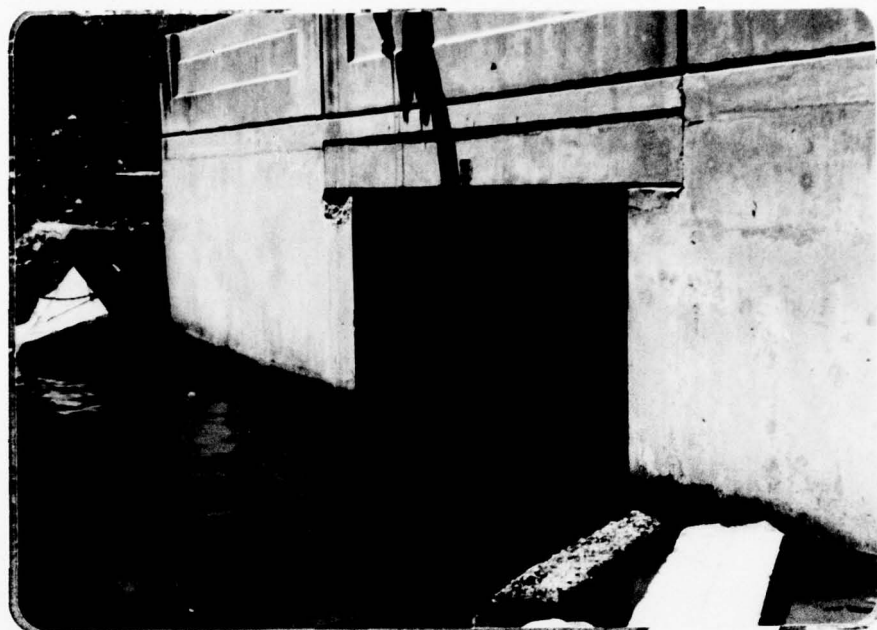
Culvert under Franklin Road

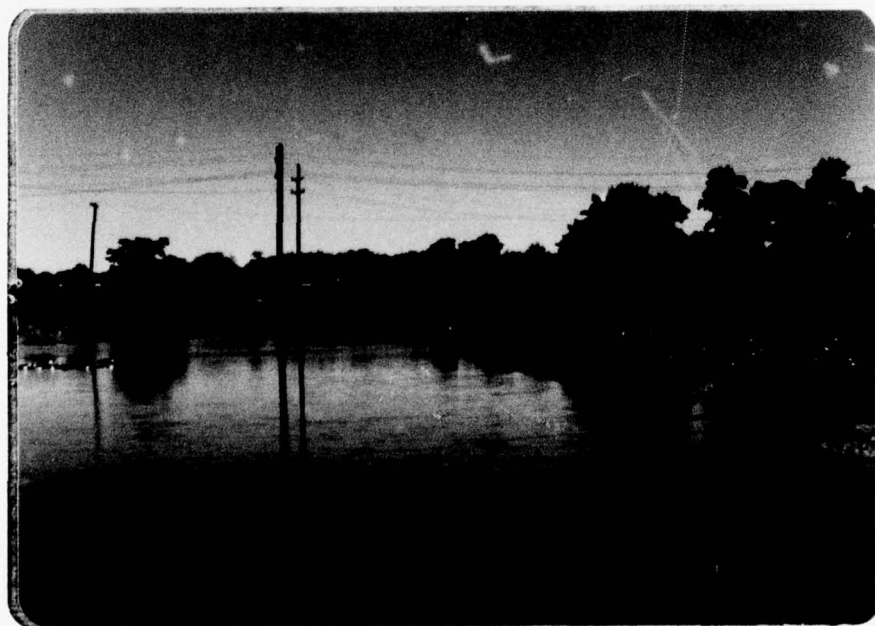
Stilling basin downstream of Indian  
Lake spillway looking Southeast
